## Memorandum

<b>To</b>	Larry Horncastle, CAO, Summer Village of Ross Haven
<b>Copy</b>	Garry MacDonald, Kyle Reiling
<b>From</b>	Alamgir Hossain
<b>Office</b>	Sherwood Park Office
<b>Date</b>	November 16, 2017
<b>File</b>	S-39447
<b>Subject</b>	Summer Village of Ross Haven (Village), 4 <sup>th</sup> Street and Driveway Construction

This technical memorandum is issued to explain how the 4<sup>th</sup> Street and associated driveway was constructed as part of the drainage improvement works undertaken in 2017.

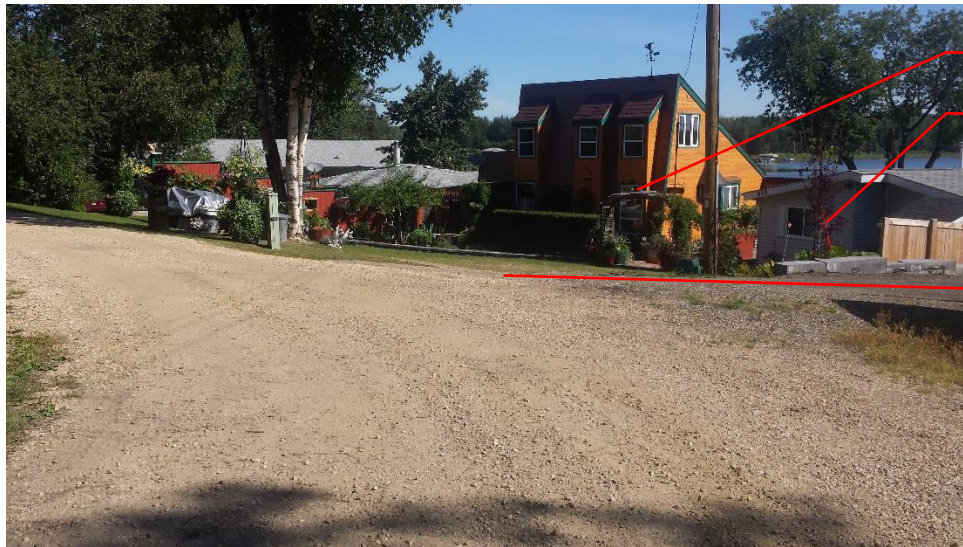
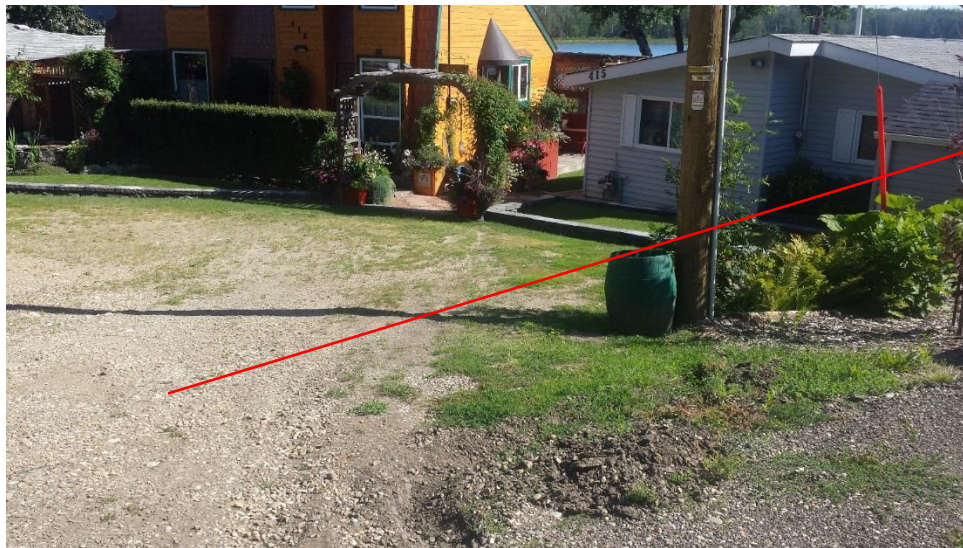
*Photo: 1a and 1b: 4<sup>th</sup> Street and Driveway, 'Before' Condition, Photo Dated July 27, 2016*

The original driveway / access to these properties was perpendicular to the 4<sup>th</sup> street alignment, with a slope gradient between 16% to 17%. (ground surveyed by Opus in April, 2017). The existing surface of this area appeared to be graveled. No geotechnical investigations were undertaken or were available to ascertain the thickness of gravel and soil conditions underneath the existing surface. Based on the visual observations and excavations undertaken during the Telus line relocation (by Telus), the existing soil in the area appeared to be mostly topsoil and clay mix. **Photo 1a and 1b** show the conditions prior to construction.

Existing  
Driveway

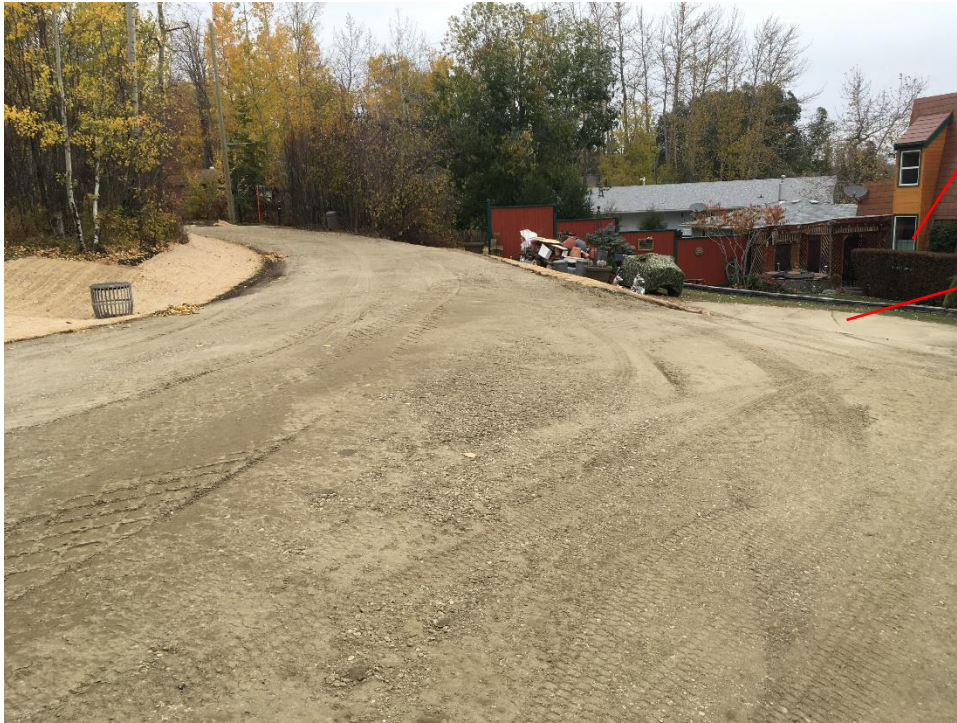
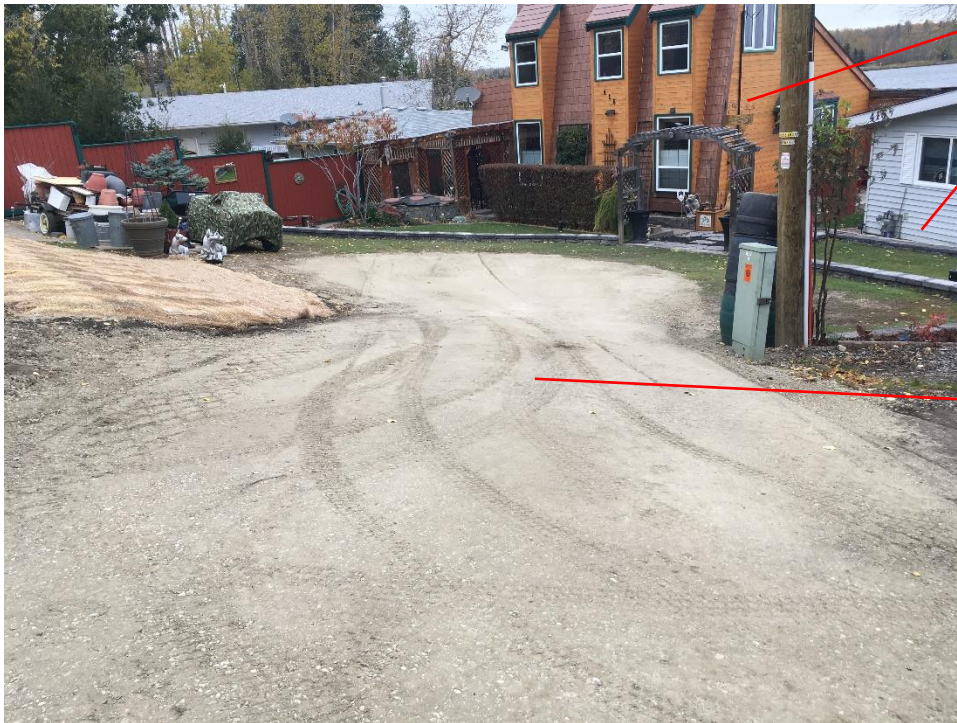
*Photo 2a and 2b:4<sup>th</sup> Street and Driveway – “After” Condition, Photo Dated Oct. 10, 2017*

The new shared driveway for Houses #416 and #415 was constructed (in September/October, 2017) more or less in the same area as originally existed but at a skewed angle with the 4<sup>th</sup> Street alignment at a slope gradient between 15% to 16% (as-built surveyed on October 13, 2017). Ground slope along the direction of original driveway (i.e. perpendicular to 4<sup>th</sup> Street) was constructed at about 28% to 30% gradient.

The new driveway was constructed by spreading new gravel material (about 125 to 150mm thick layer) on top of the existing ground and compacted with a vibratory smooth drum roller (Caterpillar 563, size 84") that was also used for compacting the roadway. Quality assurance was based on visual observations and ensuring appropriate construction equipment was used and procedures were followed. Performance under actual traffic movement on the newly constructed areas were also observed as part of quality assurance.

In our opinion, the structure of the as-constructed driveway is equal or better than the structural conditions that existed on the original driveway. Although the two alignments are different (i.e. perpendicular to 4<sup>th</sup> Street in case of the original driveway vs. skewed angle with 4<sup>th</sup> Street in case of the new driveway), the longitudinal slope of the new driveway (15% to 16%) is in the same range as that of the original driveway (16% to 17%).

The topsoil and clay mix underneath the driveway is not an ideal sub-base material for a roadway / driveway and it is anticipated that some settlements will occur over the time. It should be noted that the structural integrity of any gravel surface used for vehicles vastly depends on the usage (vehicle type/weight, speed, breaks / acceleration rates etc.) and typically requires some level of maintenances from time to time. Considering the existing underlying soil conditions and anticipated maintenance requirements, cement stabilization of the new driveway was suggested (during joint inspection on October 18<sup>th</sup>) to further improve the overall structural strength of the driveway. Details of the cement stabilization method were provided to the Village following the joint inspection. It is our understanding that the cement stabilization option is under Village's active consideration subjected to further consultation / agreement with the owners of House #416 and #415.

New Driveway
